Issue No. : Issue 6
Issue Date : April 2021
Project No. : 1825

**VERIFICATION SURVEY
REPORT ON GNETUM
LUOFUENSE**

**PORT SHELTER PHASE 3, PO
TOI O SEWERAGE
TREATMENT PLANT EM&A**

Prepared by
Allied Environmental Consultants Limited
In Association with
China Hong Kong Ecology Consultants Ltd.

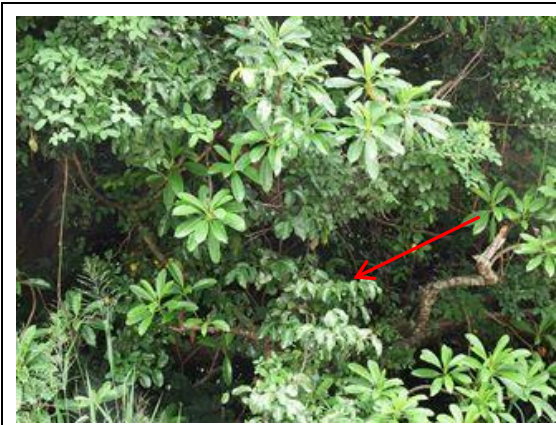
Photo 7. *Gnetum luofuense* (G3) / Roadside near the Proposed Sewage Treatment Plant

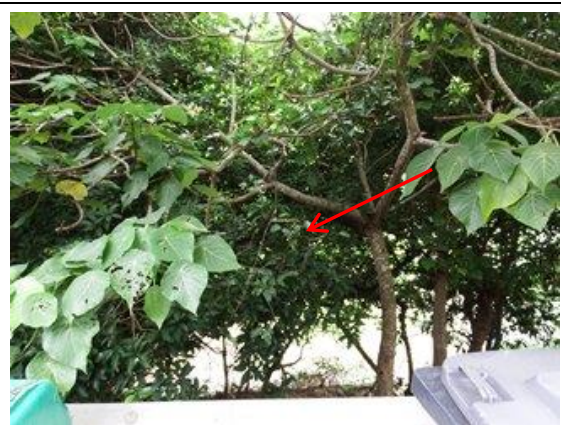
Photo 8. *Gnetum luofuense* (G4) / Roadside near the Proposed Sewage Treatment Plant

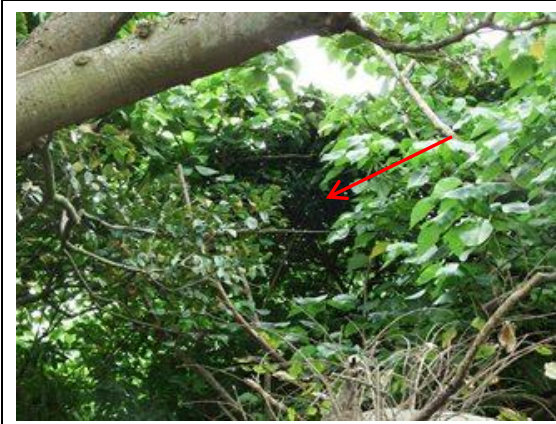
Photo 9. *Gnetum luofuense* (G5) / Fringe of woodland near the Proposed Submarine Outfall

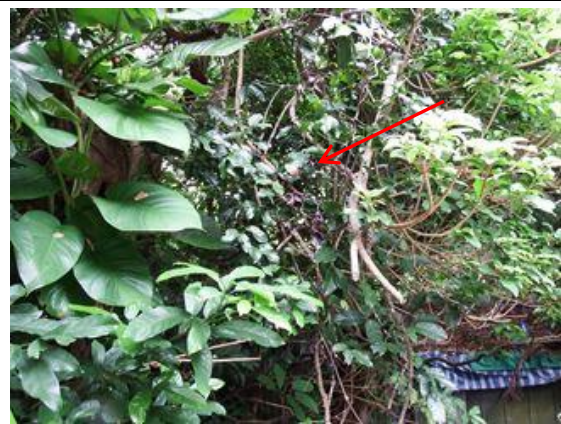
Photo 10. *Gnetum luofuense* (G6) / Roadside near the Fairway Vista

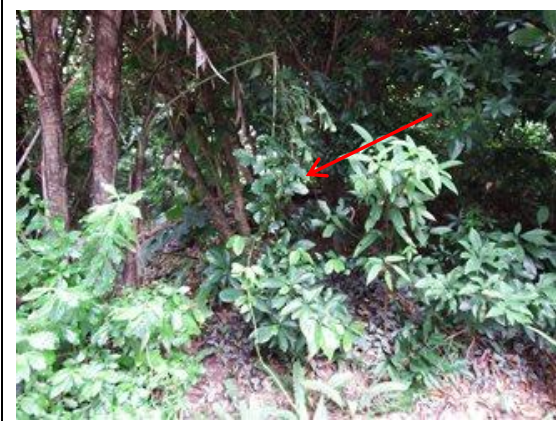
Photo 11. *Gnetum luofuense* (G7) / Roadside near the Fairway Vista

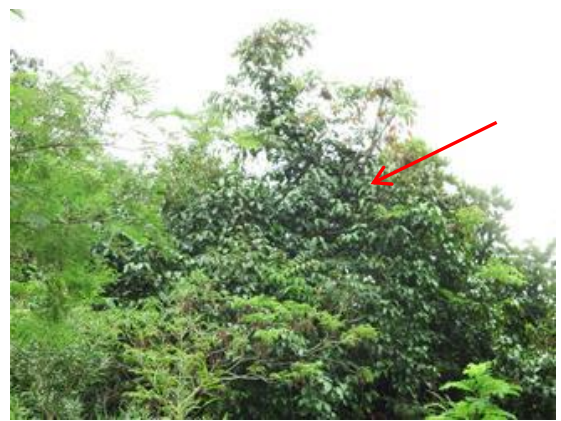
Photo 12. *Gnetum luofuense* (G8) / Fringe of woodland outside the project boundary

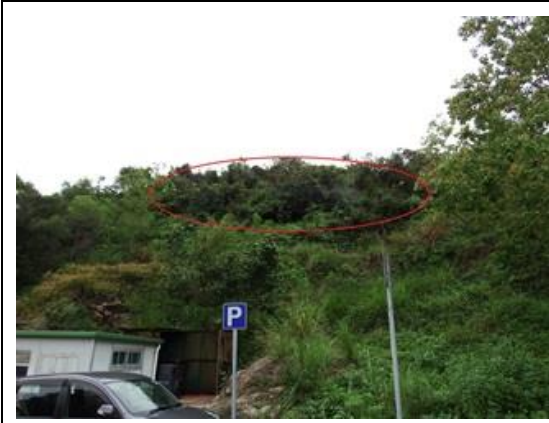
limited site area for the proposed STP, cut slope in the vicinity of G1 is necessary. Due to the abovementioned constraint, it is therefore concluded and that *Gnetum luofuense* (G1) was unavoidable to directly lost. Thus, G1 was proposed to be removed.

Photo 13. Affected area of *Gnetum luofuense* (G1)

Impact and mitigation measures	Recommended Measures
<i>Gnetum luofuense</i> (G1)	Direct loss of whole clumps may be anticipated.	Proposed to remove the whole individual as indicated in Photo 13 .
<i>Gnetum luofuense</i> (G2)	Direct loss of part of these clumps may be anticipated.	Proposed to prune the affected area as indicated in Photo 14 .
<i>Gnetum luofuense</i> (G3)	Direct loss of part of these clumps may be anticipated.	Proposed to prune the affected area as indicated in Photo 15 .
<i>Gnetum luofuense</i> (G4)	Direct loss of part of these clumps may be anticipated.	Proposed to prune the affected area as indicated in Photo 16 .
<i>Gnetum luofuense</i> (G5)	Impact avoided	No measure is proposed.
<i>Gnetum luofuense</i> (G6)	Impact avoided	No measure is proposed.
<i>Gnetum luofuense</i> (G7)	Impact avoided	No measure is proposed.
<i>Gnetum luofuense</i> (G8)	Impact avoided	No measure is proposed.

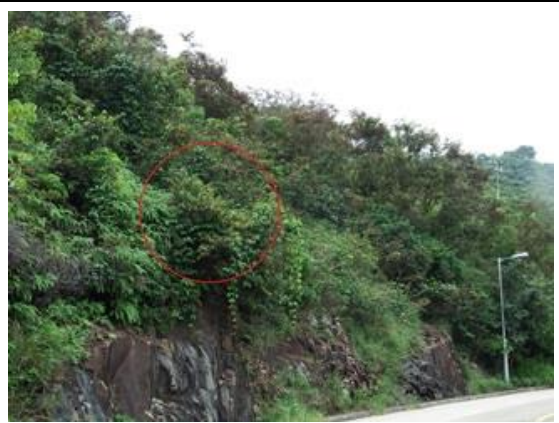
5.3 G2 to G4 were recorded on the proposed sewage treatment plant and rising main, where direct loss of part of these clumps may be anticipated. The construction area and contractor's temporary works areas are reduced as far as permissible to avoid the direct impact of G2 to G4 as far as permissible. However, due to the limited site area available for the construction of rising main and sewers and proposed STP, direct impact of G2 to G4 are unavoidable. Upon review of the proposed layout of the proposed STP and rising main, it is concluded that direct loss of G2 to G4 have been avoided as far as permissible, but direct impact of G2 to G4 is not possible to be avoided. With consideration of the abovementioned constraint, to minimise the direct impact of G2 to G4, small scale pruning of affected area of the clumps G2 to G4 (indicated in **Photos 13 to 16** and **Figure 2**) is to be completed to avoid the direct loss of G2-G4, if necessary. Such small scale pruning will not significantly affect the survival of the species. The pruning should be conducted under inspection by a qualified local ecologist / botanist with at least 10 years relevant experience to be certified by the Environmental Team and verified by the Independent Environmental Checker to minimize the impact to the species. Impact and recommended measures on the recorded *Gnetum luofuense* were summarised in **Table 2**.

Photo 14. Affected area of *Gnetum luofuense* (G2)

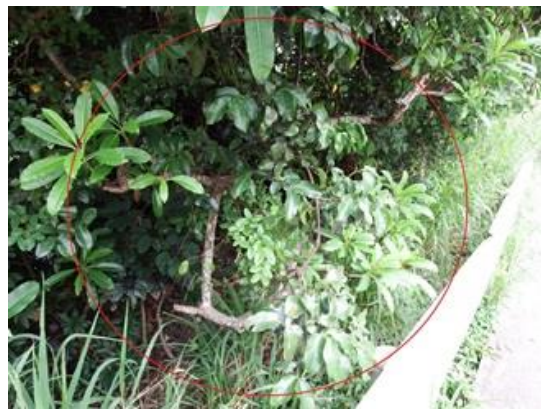
Photo 15. Affected area of *Gnetum luofuense* (G3)

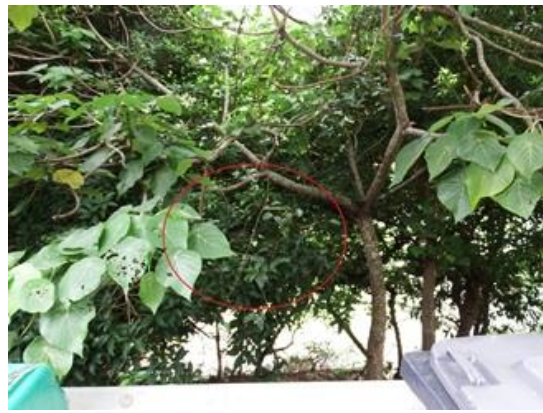
Photo 16. Affected area of *Gnetum luofuense* (G4)
