Issue No. : Issue 6
Issue Date : April 2021
Project No. : 1825

**VERIFICATION SURVEY
REPORT ON GNETUM
LUOFUENSE**

**PORT SHELTER PHASE 3, PO
TOI O SEWERAGE
TREATMENT PLANT EM&A**

Prepared by
Allied Environmental Consultants Limited
In Association with
China Hong Kong Ecology Consultants Ltd.

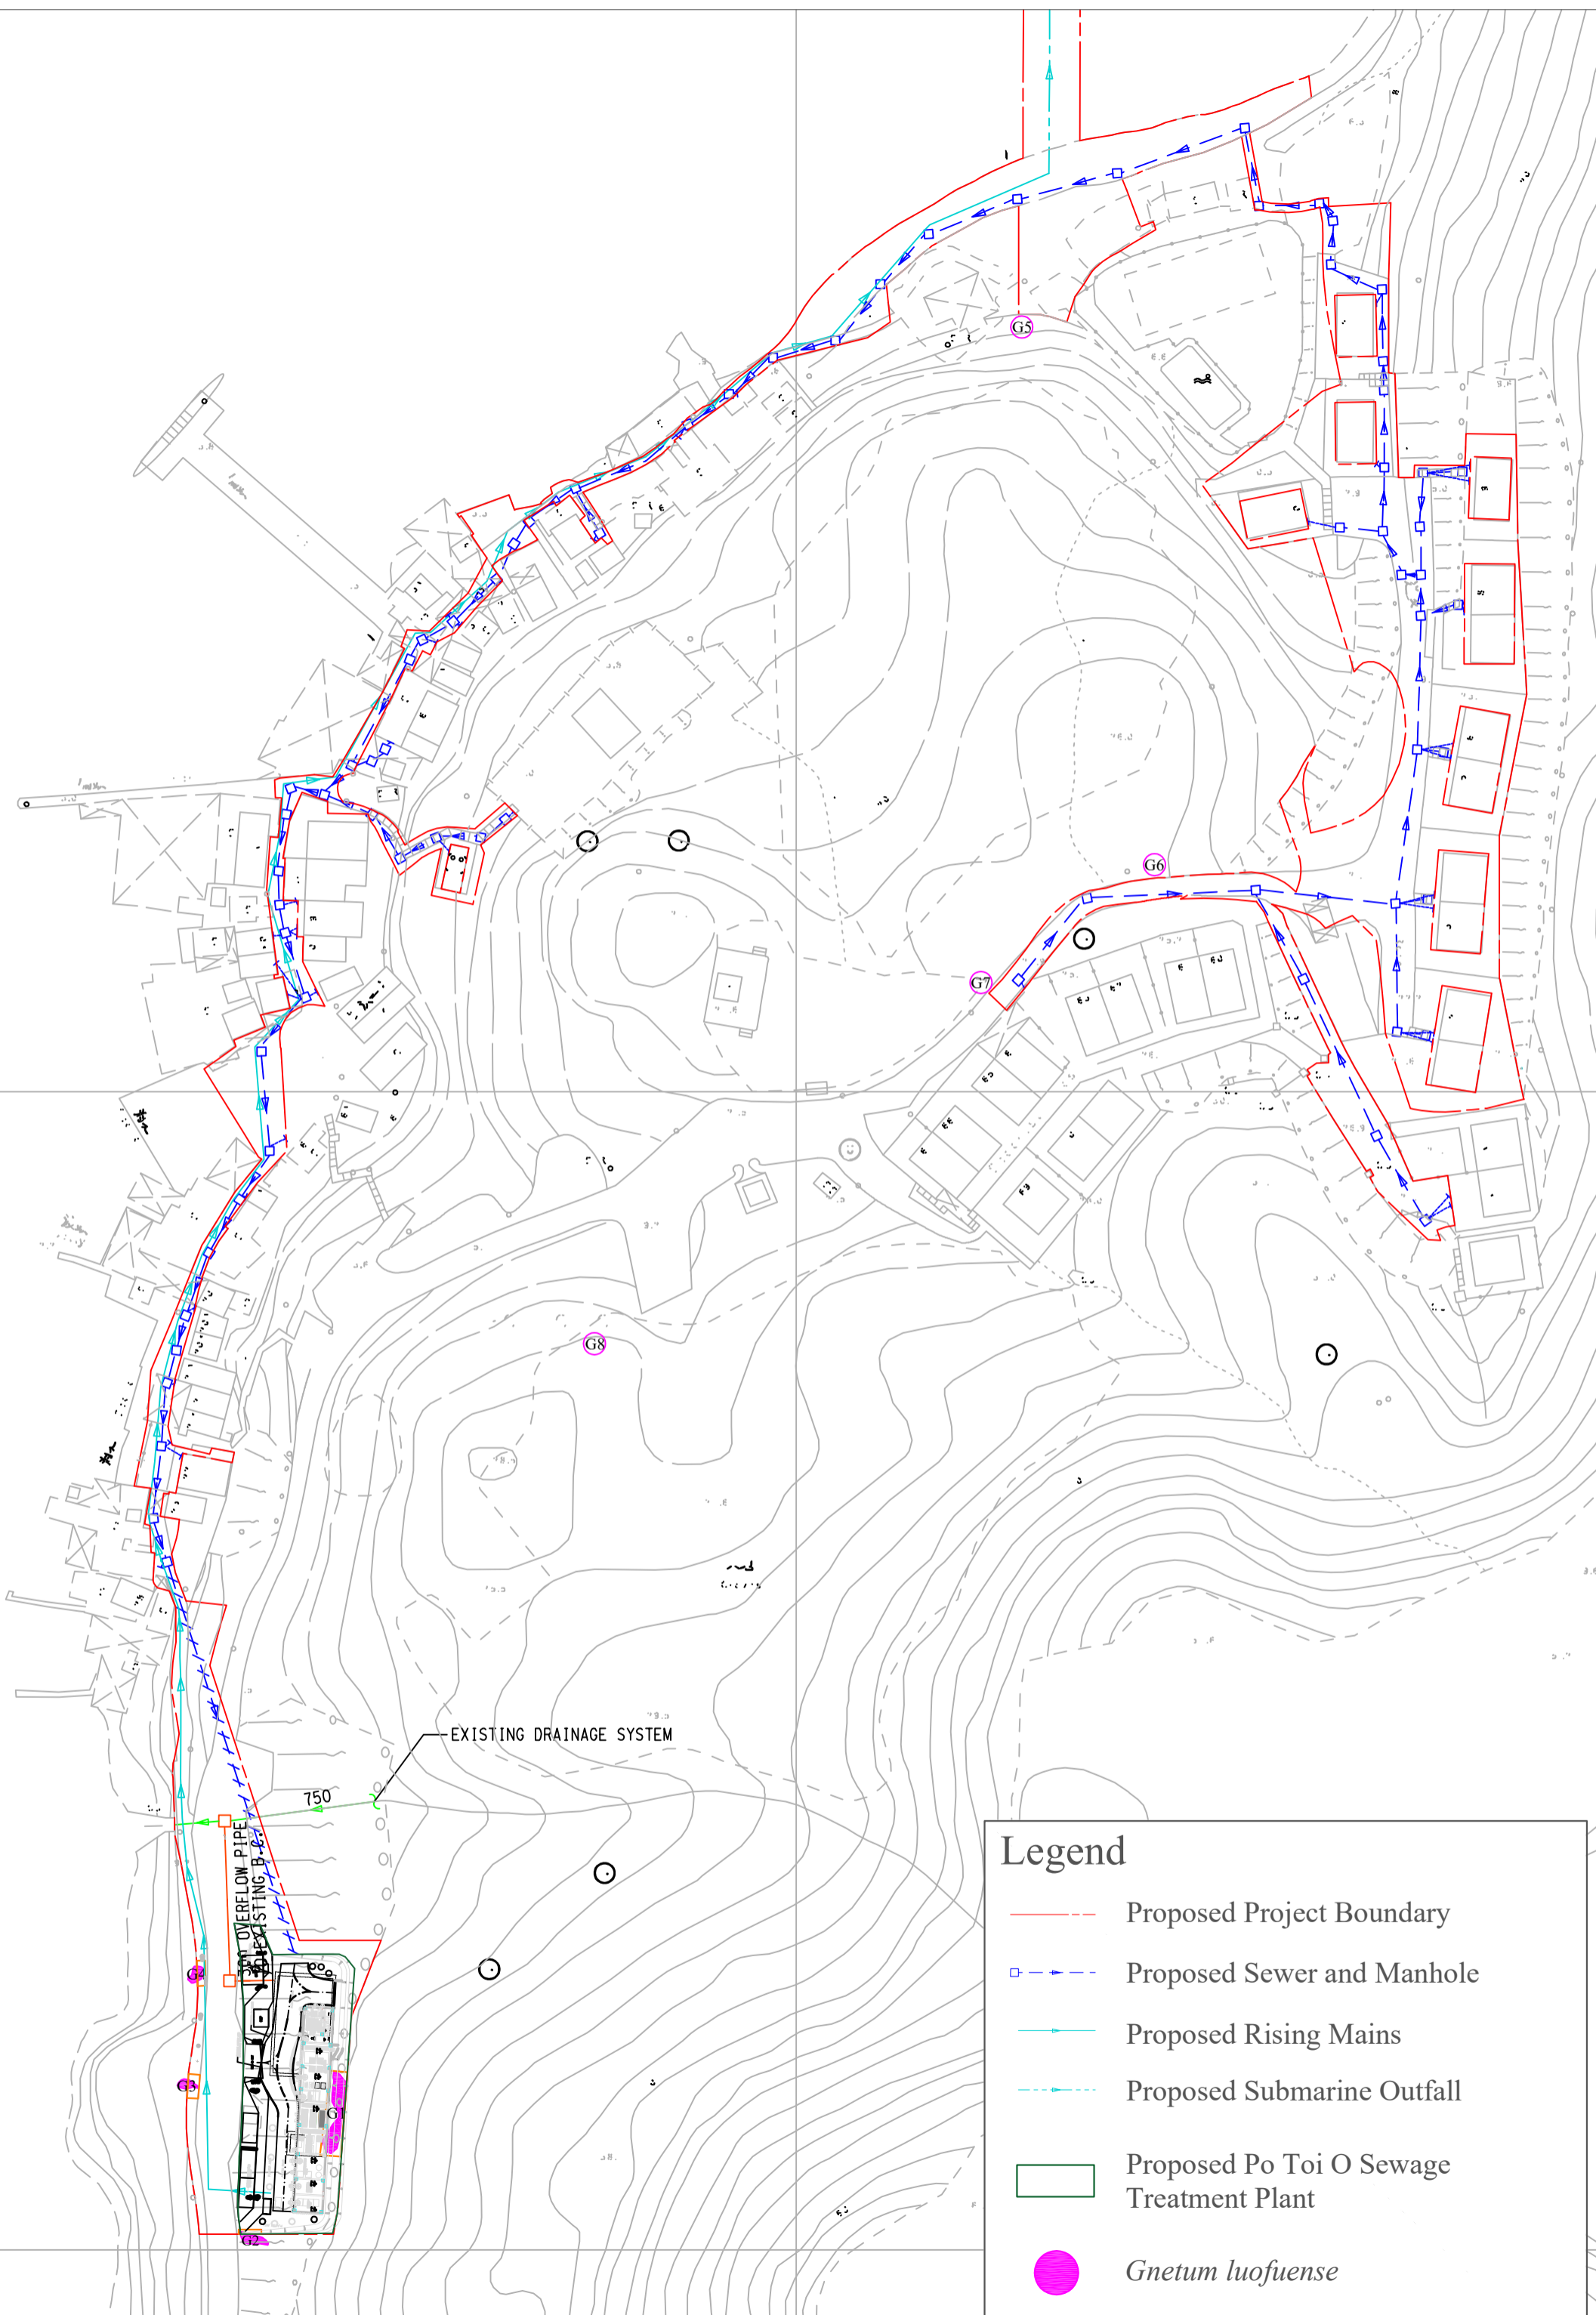
Figure 1. Survey Area and Location of *Gnetum luofuense*

4.2 In total, eight clumps of *Gnetum luofuense* were recorded during the survey. Most of *Gnetum luofuense* were recorded adjacent to the project boundary. The location of *Gnetum luofuense* was marked on topographical plan (**Figure 1**). The representative photo records of the recorded *Gnetum luofuense* are shown in **Appendix 1**. The conditions of the recorded *Gnetum luofuense* were shown in **Table 1**. All of them were

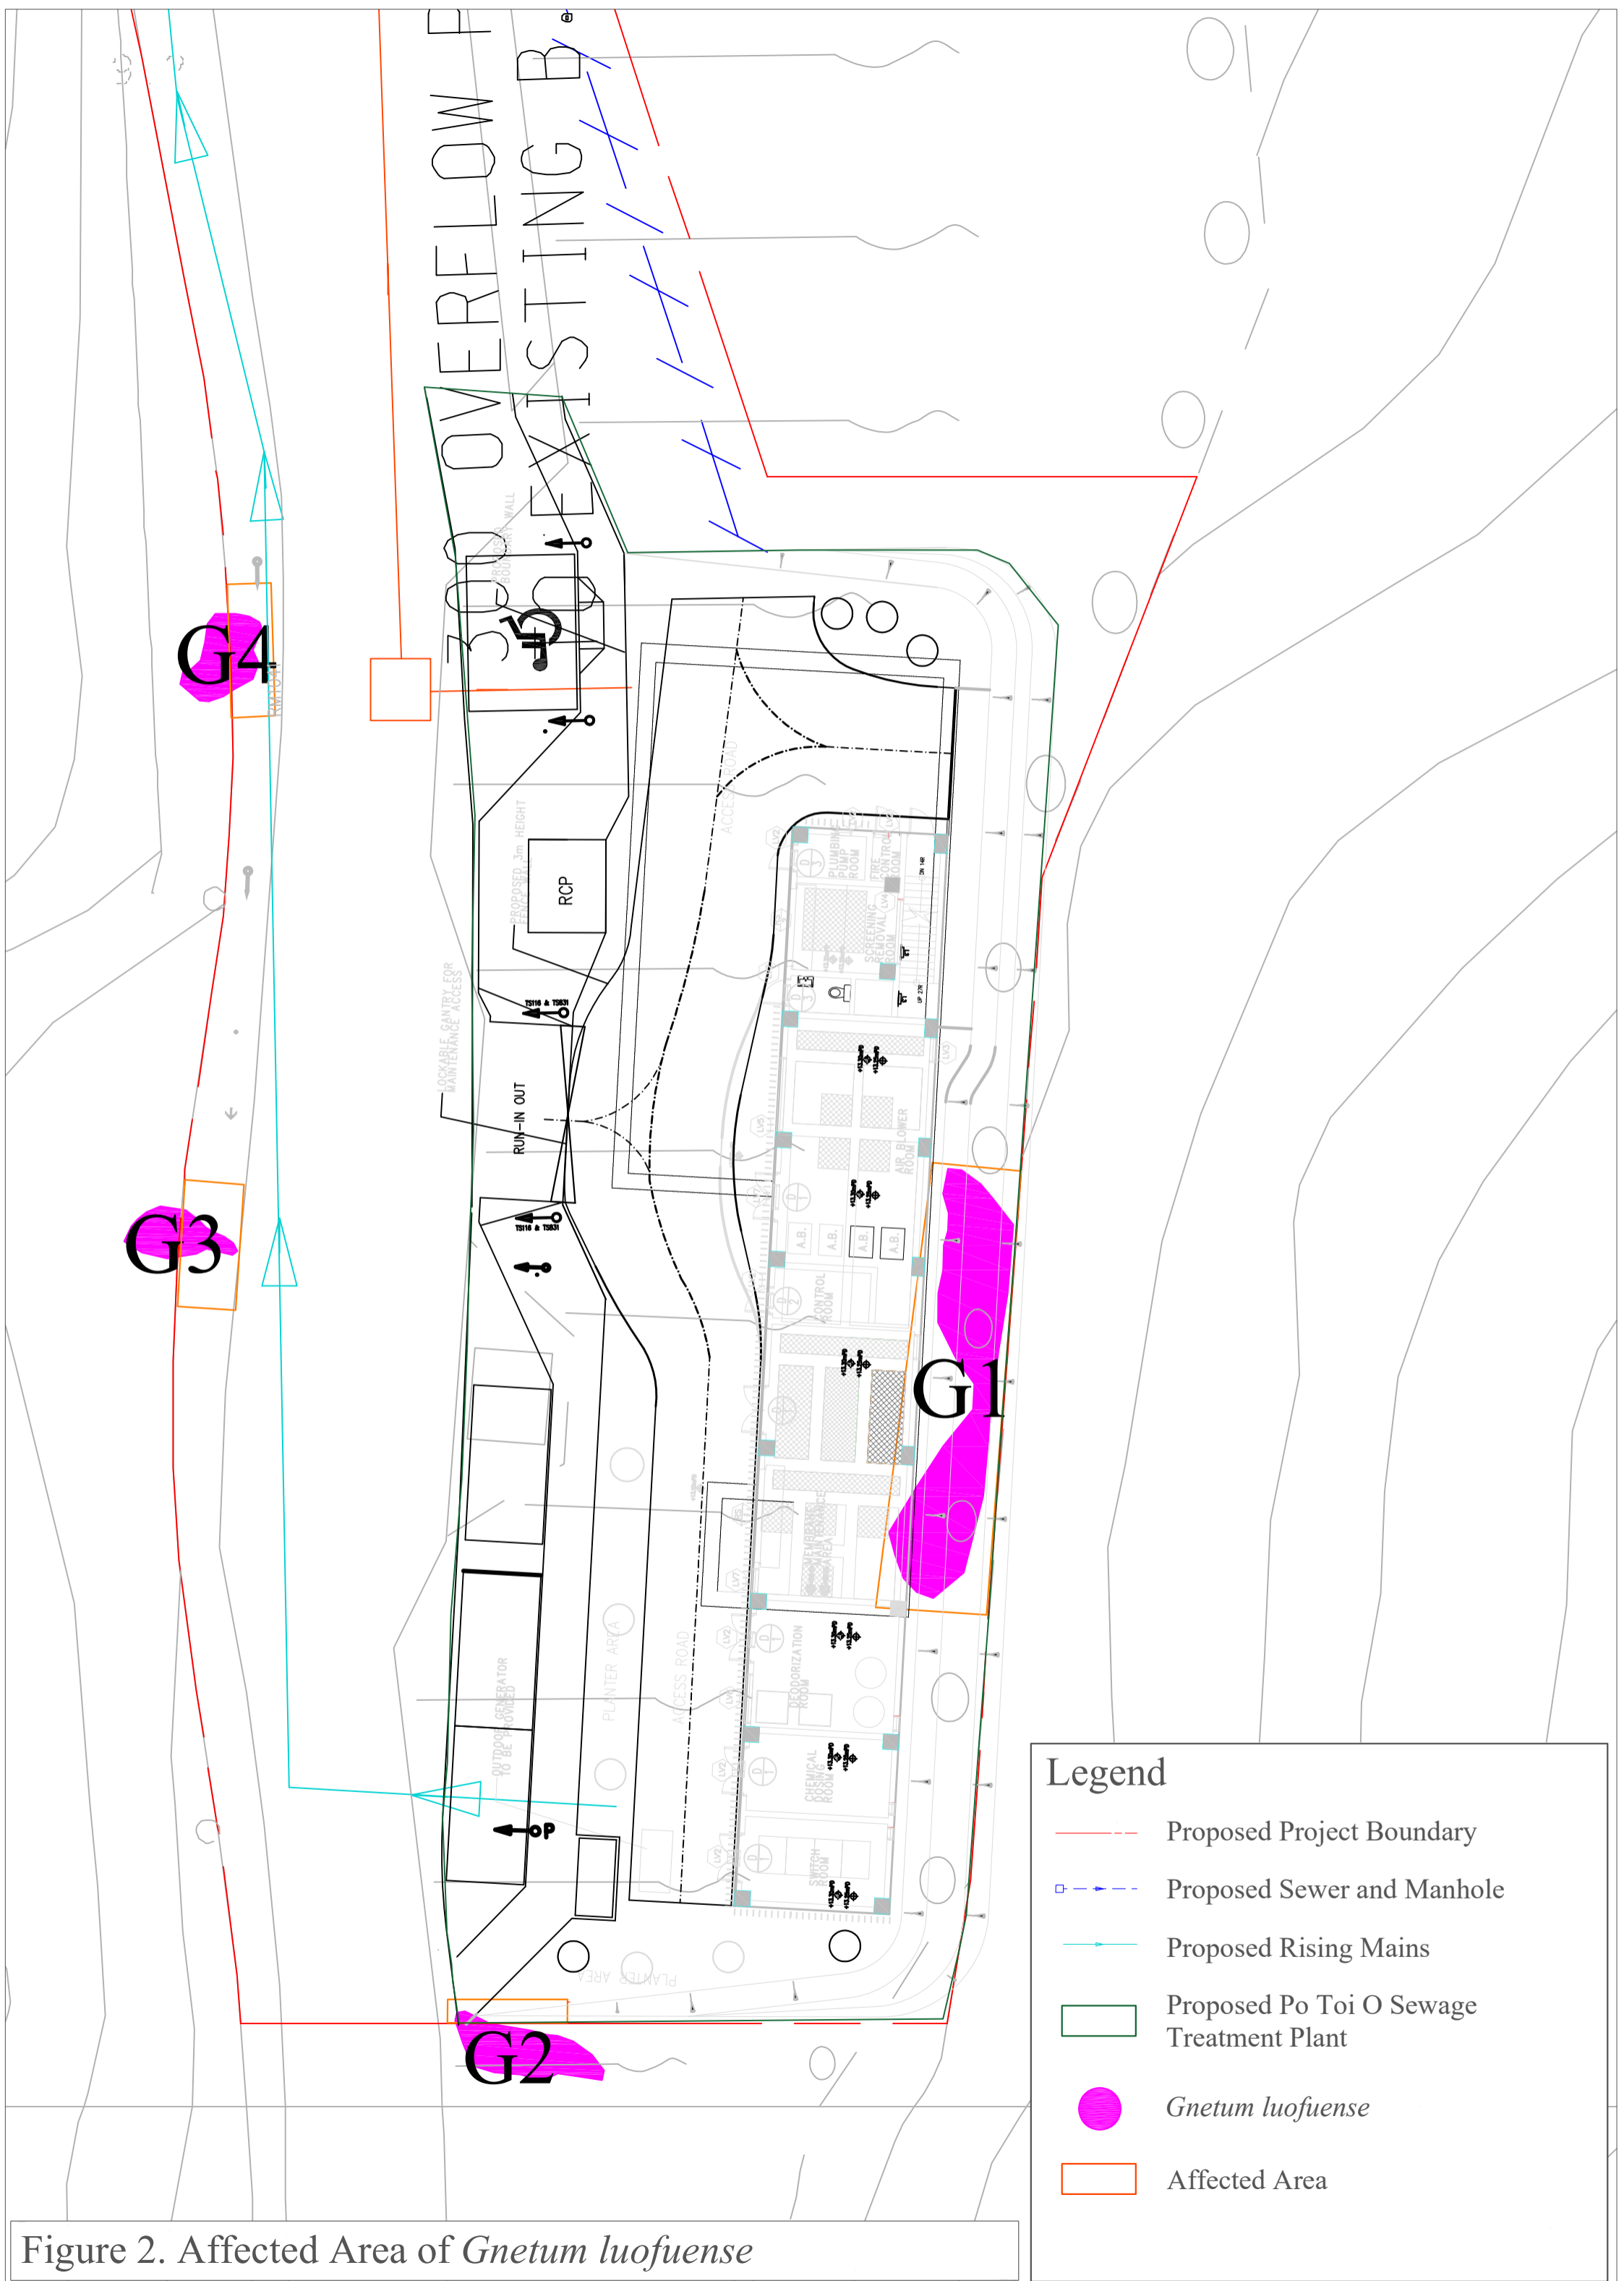
Figure 2. Affected Area of *Gnetum luofuense*

5.3 G2 to G4 were recorded on the proposed sewage treatment plant and rising main, where direct loss of part of these clumps may be anticipated. The construction area and contractor's temporary works areas are reduced as far as permissible to avoid the direct impact of G2 to G4 as far as permissible. However, due to the limited site area available for the construction of rising main and sewers and proposed STP, direct impact of G2 to G4 are unavoidable. Upon review of the proposed layout of the proposed STP and rising main, it is concluded that direct loss of G2 to G4 have been avoided as far as permissible, but direct impact of G2 to G4 is not possible to be avoided. With consideration of the abovementioned constraint, to minimise the direct impact of G2 to G4, small scale pruning of affected area of the clumps G2 to G4 (indicated in **Photos 13 to 16** and **Figure 2**) is to be completed to avoid the direct loss of G2-G4, if necessary. Such small scale pruning will not significantly affect the survival of the species. The pruning should be conducted under inspection by a qualified local ecologist / botanist with at least 10 years relevant experience to be certified by the Environmental Team and verified by the Independent Environmental Checker to minimize the impact to the species. Impact and recommended measures on the recorded *Gnetum luofuense* were summarised in **Table 2**.

Impact and mitigation measures	Recommended Measures
<i>Gnetum luofuense</i> (G1)	Direct loss of whole clumps may be anticipated.	Proposed to remove the whole individual as indicated in Photo 13 .
<i>Gnetum luofuense</i> (G2)	Direct loss of part of these clumps may be anticipated.	Proposed to prune the affected area as indicated in Photo 14 .
<i>Gnetum luofuense</i> (G3)	Direct loss of part of these clumps may be anticipated.	Proposed to prune the affected area as indicated in Photo 15 .
<i>Gnetum luofuense</i> (G4)	Direct loss of part of these clumps may be anticipated.	Proposed to prune the affected area as indicated in Photo 16 .
<i>Gnetum luofuense</i> (G5)	Impact avoided	No measure is proposed.
<i>Gnetum luofuense</i> (G6)	Impact avoided	No measure is proposed.
<i>Gnetum luofuense</i> (G7)	Impact avoided	No measure is proposed.
<i>Gnetum luofuense</i> (G8)	Impact avoided	No measure is proposed.
