MONTHLY ENVIRONMENTAL MONITORING & AUDIT REPORT (APRIL 2022)

PORT SHELTER PHASE 3, PO TOI O SEWERAGE TREATMENT PLANT

Prepared by

Allied Environmental Consultants Limited

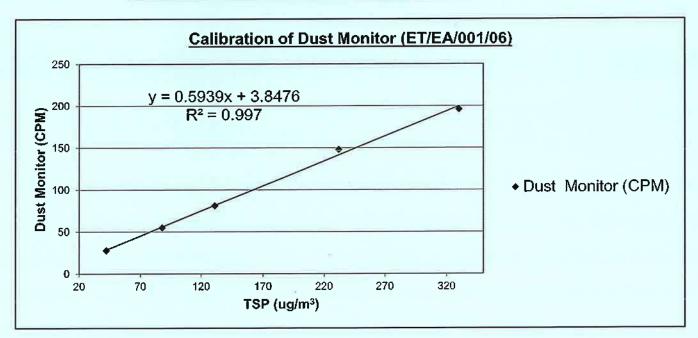
Dust Monitor (CPM)	28	<b>5</b> 5	81	148	196				
TSP (ug/m <sup>3</sup> )	42	88	131	232	330				
High Volume Air Sampler Serial No.: 1180	olume Air Sampler Serial No.: 1180 Calibration Due Date: 10 March 2022

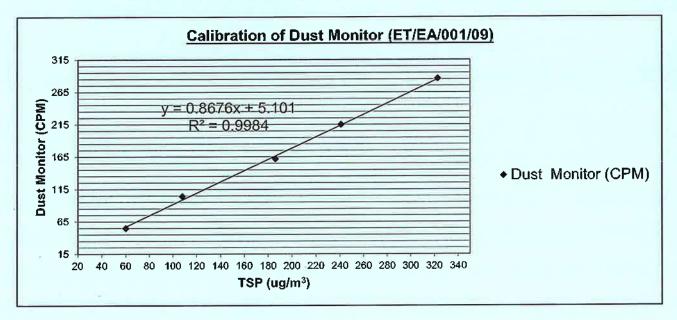
Dust Monitor (CPM)	55	104	162	215	286			
TSP (ug/m <sup>3</sup> )	60	108	186	241	323			
High Volume Air Sampler Serial No.: 9795	Calibrati	Calibration Due Date: 09 March 2022

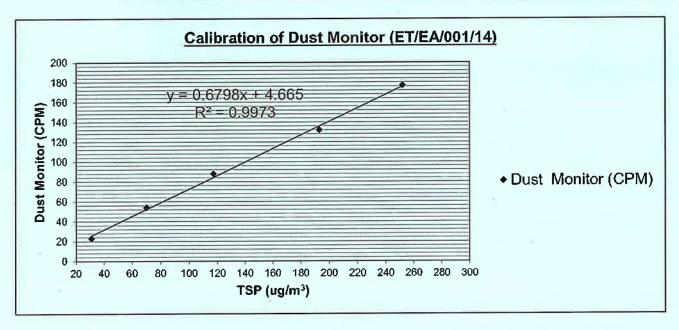
Dust Monitor (CPM)	23	54	88	132	177			
TSP (ug/m³)	31	70	117	193	252			
High Volume Air Sampler, Serial No.: 1174	Calibration Due Date: 10 March 2022

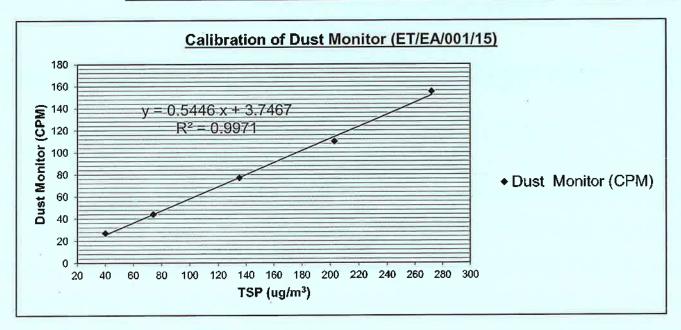
Dust Monitor (CPM)	27	44	77	110	155		
TSP (ug/m <sup>3</sup> )	40	74	135	203	272		
High Volume Air Sampler Serial No : 2483	Calibration Due Date: 10 March 2022

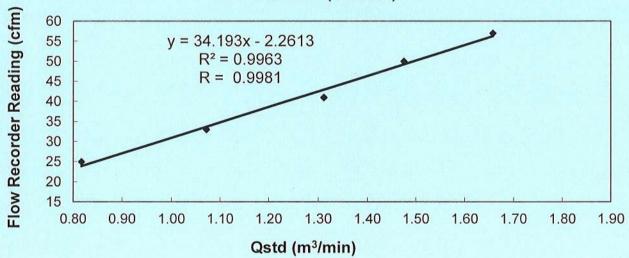
### Sampler 1180 Calibration Curve Site: Tuen Mun (TM-RA2)

Acceptance Criteria: Correlation coefficient (r) of the calibration curve greater than 0.990 after a 5-point calibration

The high volume sampler complies\* / does not comply\* with the specified requirements and is deemed acceptable\* / unacceptable \* for use.

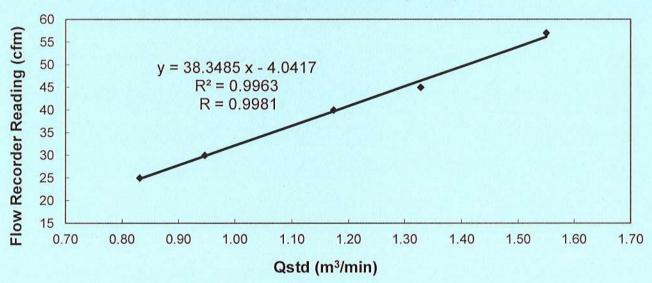
### Sampler 1174 Calibration Curve Site: Tuen Mun CWSF (TM1a)

Acceptance Criteria: Correlation coefficient (r) of the calibration curve greater than 0.990 after a 5-point calibration.

The high volume sampler complies\* / does not comply\* with the specified requirements and is deemed acceptable\* / unacceptable\* for use.

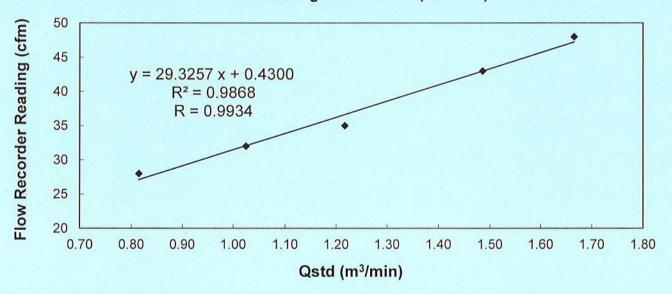
### Sampler 9795 Calibration Curve Site: Tseung Kwan O 137 (TKO-A1)

Acceptance Criteria: Correlation coefficient (r) of the calibration curve greater than 0.990 after a 5-point calibration

The high volume sampler complies\* / does not comply\* with the specified requirements and is deemed acceptable\*/ unacceptable\* for use.

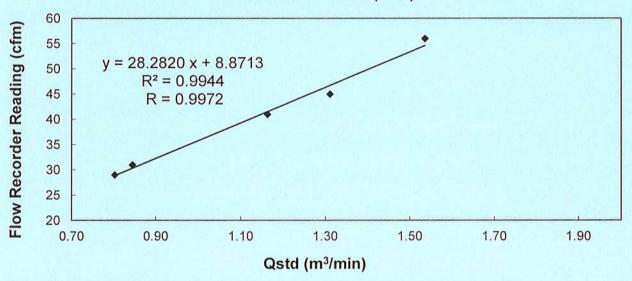
### Sampler 2483 Calibration Curve Site: Tuen Mun CWSF (TM2)

Acceptance Criteria: Correlation coefficient (r) of the calibration curve greater than 0.990 after a 5-point calibration

The high volume sampler complies\* / does not comply\* with the specified requirements and is deemed acceptable\*/ unacceptable\* for use.

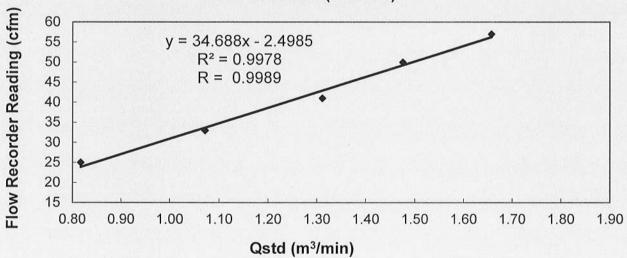
### Sampler 1180 Calibration Curve Site: Tuen Mun (TM-RA2)

Flow recorder reading (cfm)  Qstd (Actual flow rate, m³/min)		55	51	44	35	27	
		1.67	1.52	1.34	1.09	0.85	
Pressure:	763.56	mm Hg		Temp.:	294	K

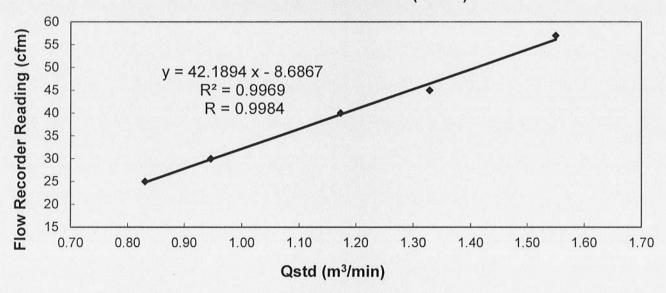
### Sampler 1174 Calibration Curve Site: Tuen Mun CWSF (TM1a)

Flow recorder reading (cfm)	58	48	41	32	26
Qstd (Actual flow rate, m³/min)	1.57	1.35	1.17	0.99	0.80
Pressure :	763.56 mm Hg	Temp. :	294	K

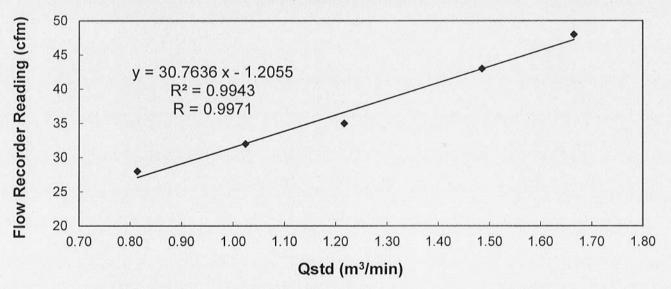
### Sampler 9795 Calibration Curve Site: Tseung Kwan O 137 (TKO-A1)

Flow recorder reading (cfm)  Qstd (Actual flow rate, m³/min)		51 1.70	46	37	32	0.83
			1.52	1.28	1.04	
Pressure: 762.81 mm Hg			Temp. :	295	К

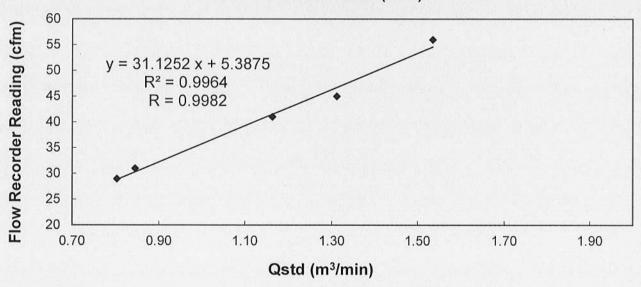
### Sampler 2483 Calibration Curve Site: Tuen Mun CWSF (TM2)

Flow recorder reading (cfm)		55	47	41	34	30
Qstd (Actual flow rate, m³/min)		1.59	1.33	1.17	0.93	0.77
Pressure :	763.56 mm	n Hg	Temp. :	294	K
