MONTHLY ENVIRONMENTAL MONITORING & AUDIT REPORT (JUNE 2022)

PORT SHELTER PHASE 3, PO TOI O SEWERAGE TREATMENT PLANT

Allied Environmental Consultants Limited

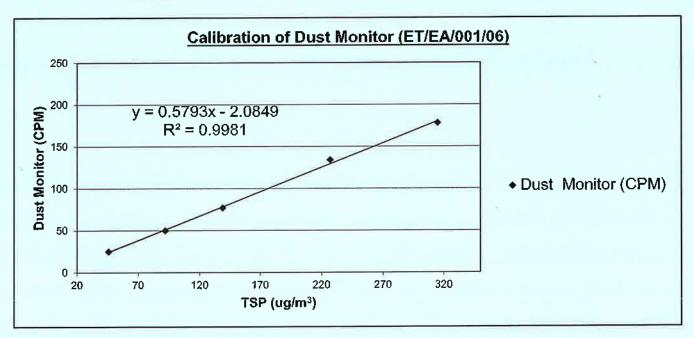
Dust Monitor (CPM)	25	50	77	134	178
TSP (ug/m ³)	46	92	139	227	315
High Volume Air Sampler, Serial No.: 1180	Calibratio	n Due Da	ate: 07 M	av 2022

Correlation coefficient (r) of the calibration curve greater than 0.990 after

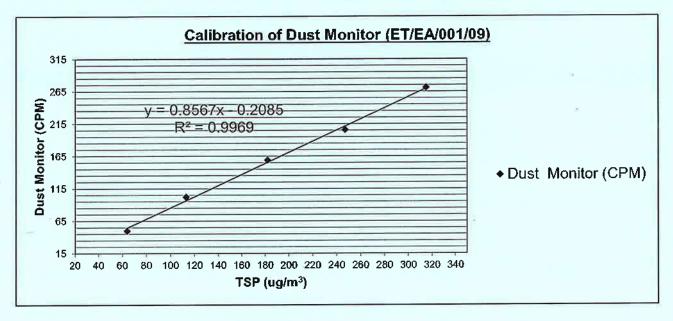
•	Dust Monitor (CPM)	50	102	159	206	271
	TSP (ug/m ³)	64	113	182	247	315
	High Volume Air Sampler Serial No.: 9795	Calibration	on Due D	ate: 08 N	lay 2022

Correlation coefficient (r) of the calibration curve greater than 0.990 after a five-point

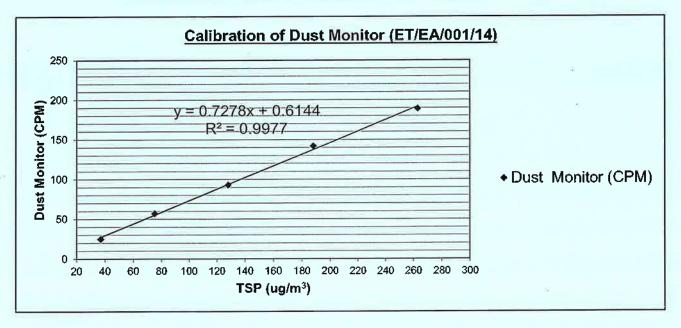
Dust Monitor (CPM)	25	57	93	142	189
TSP (ug/m ³)	37	75	128	188	263
High Volume Air Sampler Serial No.: 1174	Calibratio	n Due Da	ite: 07 M	ay 2022

Correlation coefficient (r) of the calibration curve greater than 0.990 after a five-point

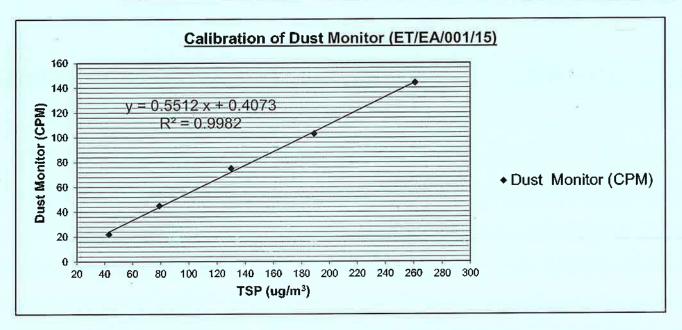
Dust Monitor (CPM)	22	45	75	103	144
TSP (ug/m³)	43	79	130	189	261
High Volume Air Sampler Serial No.: 2483	Calibratio	n Due Da	te: 07 M	ay 20 2 2

Correlation coefficient (r) of the calibration curve greater than 0.990 after a five-point

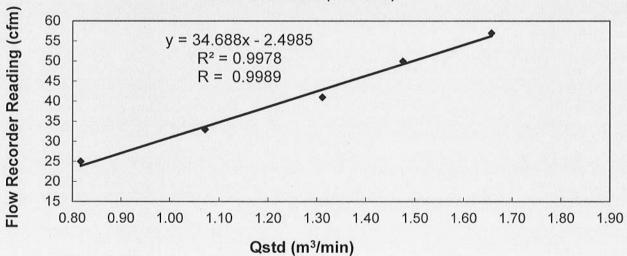
Sampler 1180 Calibration Curve Site: Tuen Mun (TM-RA2)

Flow recorder rea	ading (cfm)		55	51	44	35	27
Qstd (Actual flow	rate, m³/min)		1.67	1.52	1.34	1.09	0.85
Pressure :	763.56	mm Hg		Temp.:	294	K

Acceptance Criteria: Correlation coefficient (r) of the calibration curve greater than 0.990 after a 5-point calibration
